## Expanding Boundaries: Systems Thinking for the Built Environment

### OVERCOMING OBSOLESCENCE: A CASE STUDY RENOVATION BUILDING - IDEAS ON REUSE IN PLANNING AND BUILDING PROCESS

This paper presents a renovation building case study. With a main focus on planning instruments and managing reuse and recycling of existing buildings and their structural features, the methods and practicalities of a building's end-of-life stage are discussed in reference to the case study building. This exemplary residential renovation building demonstrates how recycling and reuse of building components could be planned, managed and implemented.

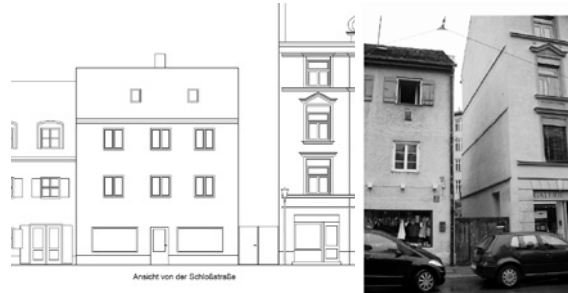
Fig. 1: Existing building: street view and existing gap between buildings.

Figure 1 shows the then existing building with the narrow gap to the adjacent building. Different options were discussed during the planning phase, including renovating the existing house, renovating the ground and first floor, renewing second floor and roof, and closing of the gap to change the entrance situation and enlarge size of flats with the additional advantage of reducing façade to exterior. Complete demolition and rebuilding was not an option due to conservation area restraints.

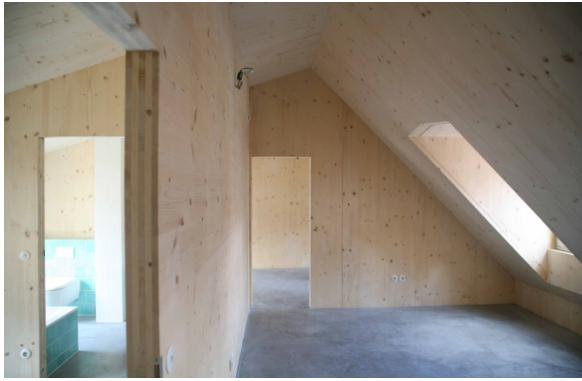
*Fig. 5: View from inside (loft extension) showing reduced material concept.*

(ii) use only a small variety of materials; (iii) rethink construction, especially joints. This delivered a reduced material concept using as much non-treated material as possible. For example, frames for doors were left out as the hocks also could be connected to the wooden walls. The wooden construction is only fixed by easily replaceable screws and steel brackets. Only the insulation of exterior façades (wooden soft fibre board) is inseparably connected to rendering.

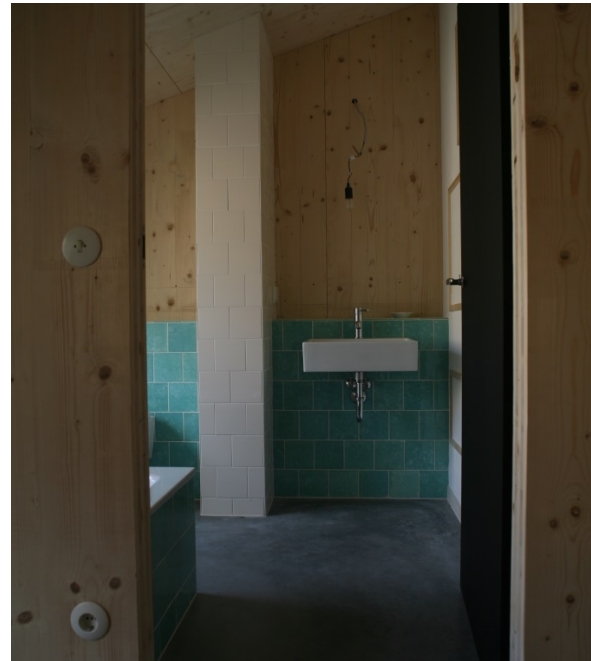
*Fig. 6: view from inside showing material concept.*

doubled as the mounting was more expensive, as two screws were always needed instead of one. The final cost of this part of electric renovation was in the end the same as using new sockets. Figure 6 shows the reuse of tiles (green) in a new context alongside additional tiles (white). Reuse of tiles was possible because of limited breakage due their thickness and careful extraction. Wood used as construction material can be reused after demolition as CLT parts for floors and still have a reasonable size and complete disassembly is possible. This can be achieved by unscrewing building parts, extracting cellulose insulation, removing floor screed, and sound protection. Only when reuse is not possible should energy recovery be an option. For the case study building, current construction drawings of building parts exist (as built) in addition a material list that are helpful for end-of-life considerations.
